Who Lowered the Roof?

By Sam McGhee
NAVOSH Manager, NAF Atsugi, Japan

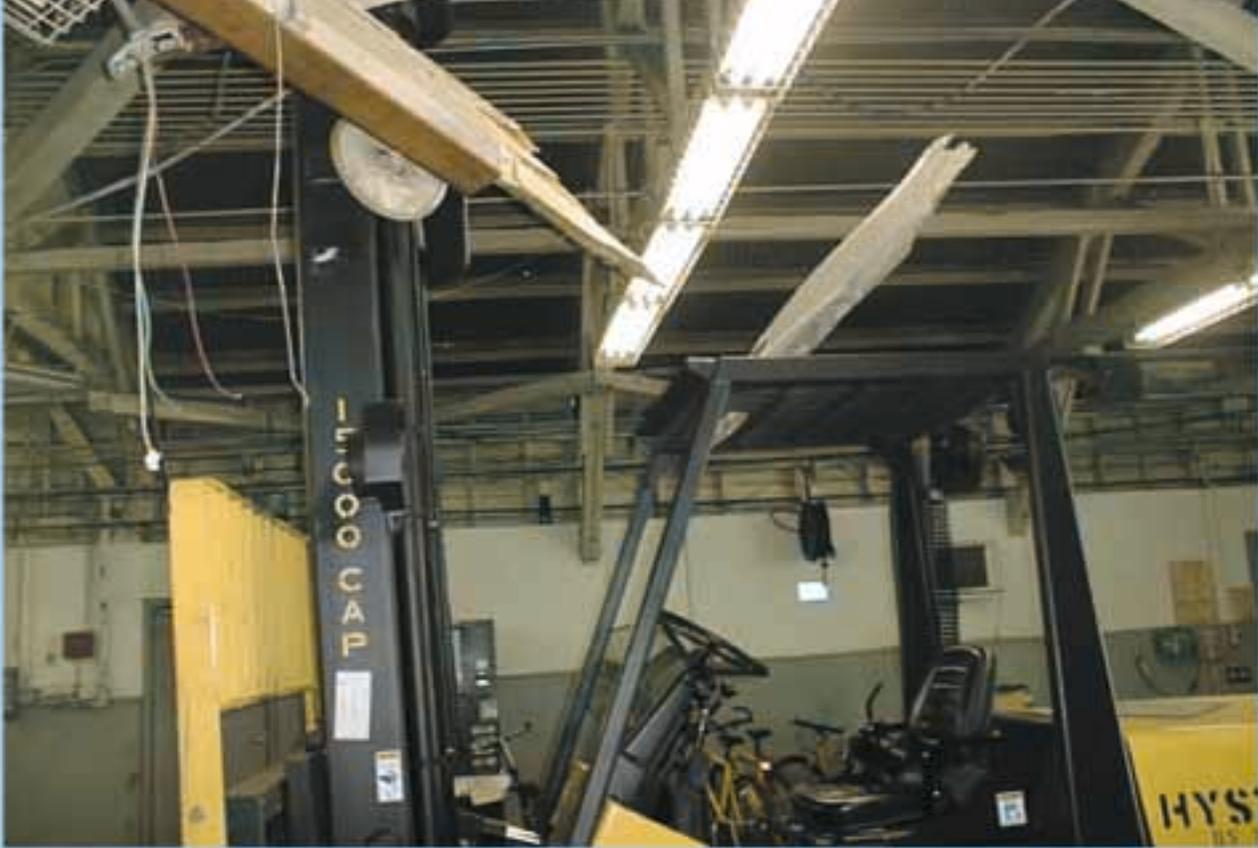
But one day, we had a problem. An operator had just finished a maintenance inspection on one of the larger lifts we operate. He drove the truck down an area of the shop where the roof supports were lower, hit the support beam of the roof, and shattered it. Even with the lift all the way down, the top of this forklift extended more than 2 feet above the beam.

If the piece of beam lodged in the roof rack of the forklift had been a little smaller and in a different location, it could have hit the operator.

In this case, some things were done wrong—our fix was to permit no forklift operations in this end of the building. I also have to give the operator a pat on the back for wearing the proper PPE for the job. ■
